STRUCTURAL ASSESSMENT

**HIDDEN COVE DEVELOPMENT
BRANDRETH PILL FACTORY**

**36 N Water St.
Ossining, NY 10562**

10 September 2012

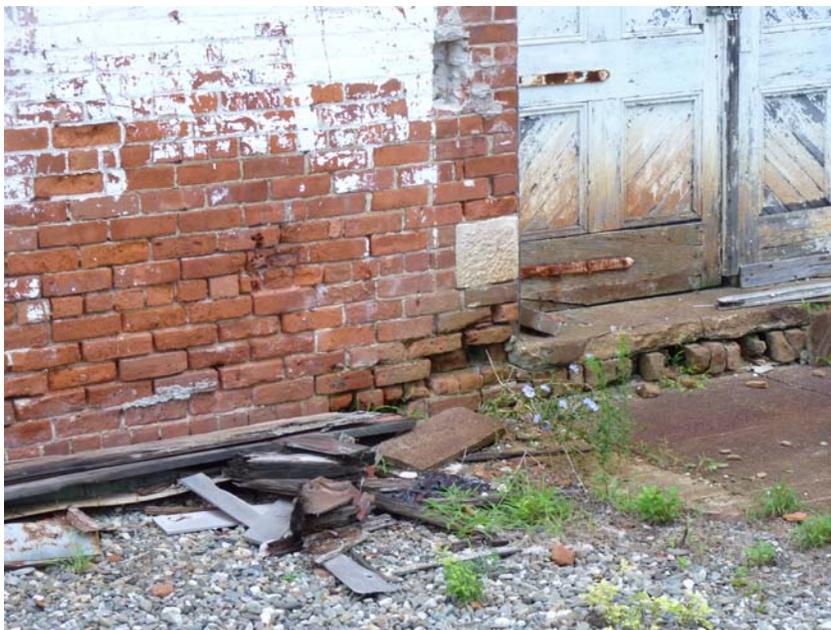
Approaching the Mill Building from the northwest, the exterior of the building shows obvious distress. Sections of the mansard soffit are missing, the brick is cracked in many places with evidence of crumbling and missing brick and mortar around the base of the walls (see Image 4). Attempts have been made to correct some of the cracking in the past, evidenced by limited tuck pointing and a parging of the

Image 4 Typical Exterior Masonry Damage
(Main Building – West Entrance)

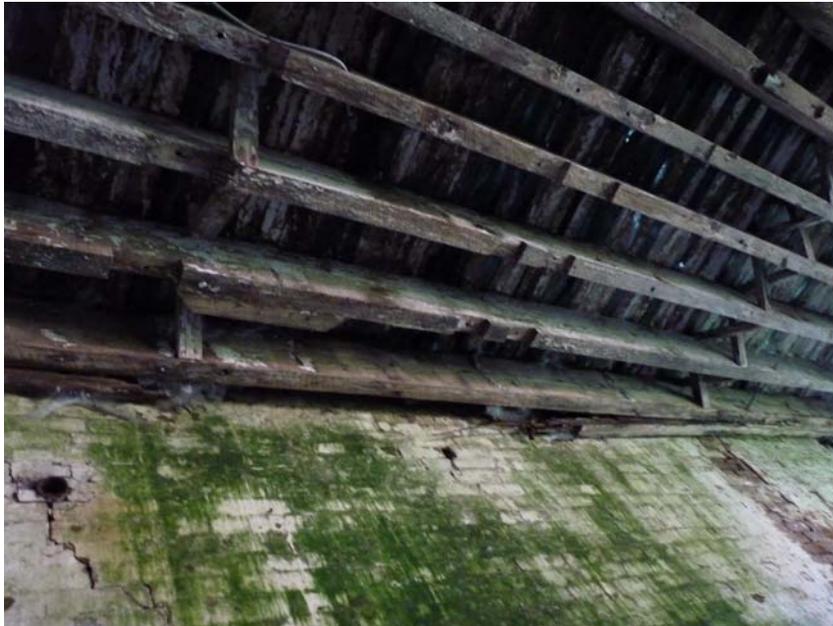
Joist bearing at interior masonry walls generally appears acceptable, but the masonry at the damaged areas was extensively cracked and decayed. The presence of moss on interior walls indicates persistent levels of high humidity (Image 5). In areas of obvious water infiltration, the bottom of the walls exhibit distress and decay including missing bricks and large amounts of masonry dust on the slab. The south wing has undergone some renovation which was incomplete. As a result, not all of the framing was visible and some repairs had been made.

Image 5 Typical Floor Framing and Masonry Water Damage (Main Building – Underside of Second Floor)

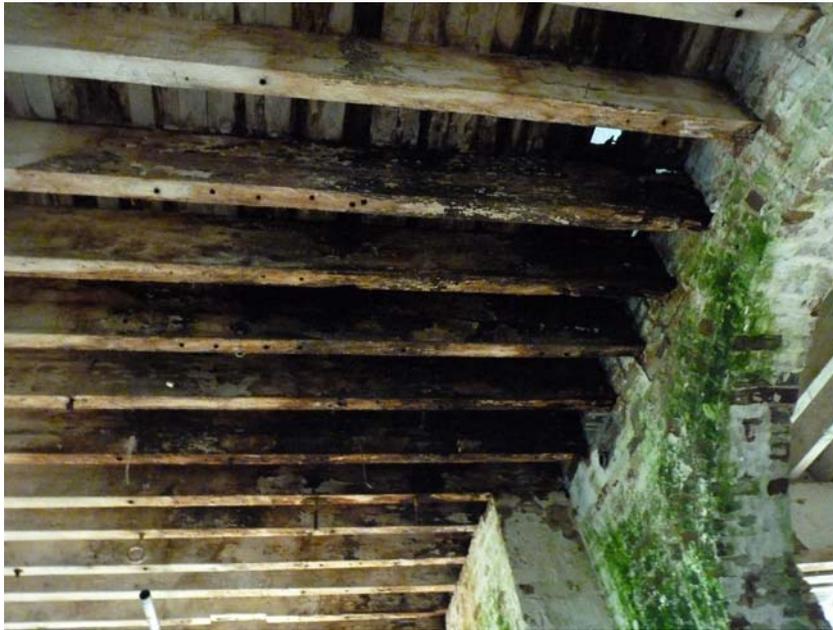
Image 6 Water Damage at Joist Bearing on Masonry Arch
(Main Building - Underside of Second Floor)

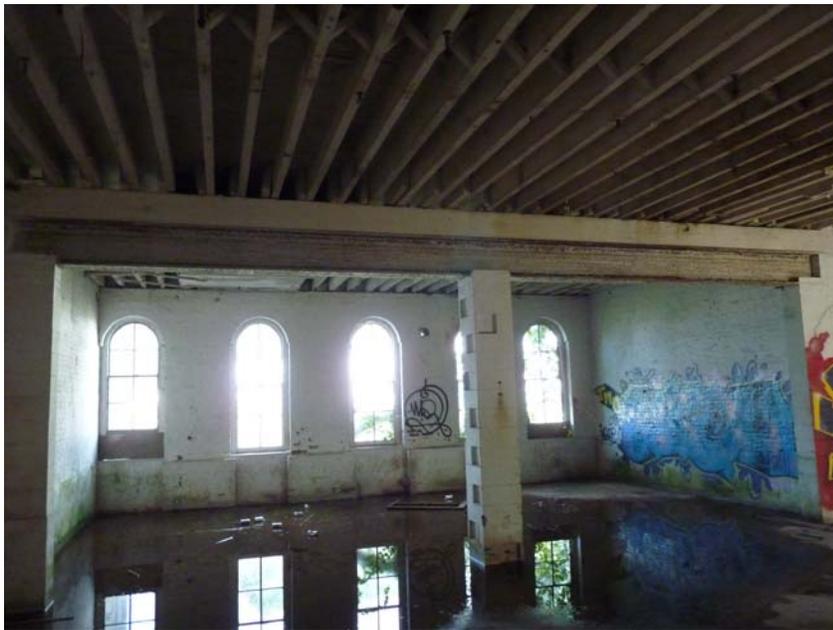
The masonry walls are all painted. Uniformly throughout the building, the paint has peeled off the bottom foot or two of the masonry. The peeling paint indicates moisture leaving the wall and is present even in areas where the bottom of the brick wall is elevated on a cmu pier or wall. The re-entrant corner of the building on the courtyard side appears to have suffered greatly. A large area of the floor is decayed, including damage to the joists, but also evident decay of the masonry arch supporting the joists framing from the north side (Image 6). The room adjacent to the water wheel had a standing puddle of water that covered most of the floor area of the room (Image 7). It appears that the central line of

Image 7 Standing Water in Wheel Room
(Main Building - Ground Floor)

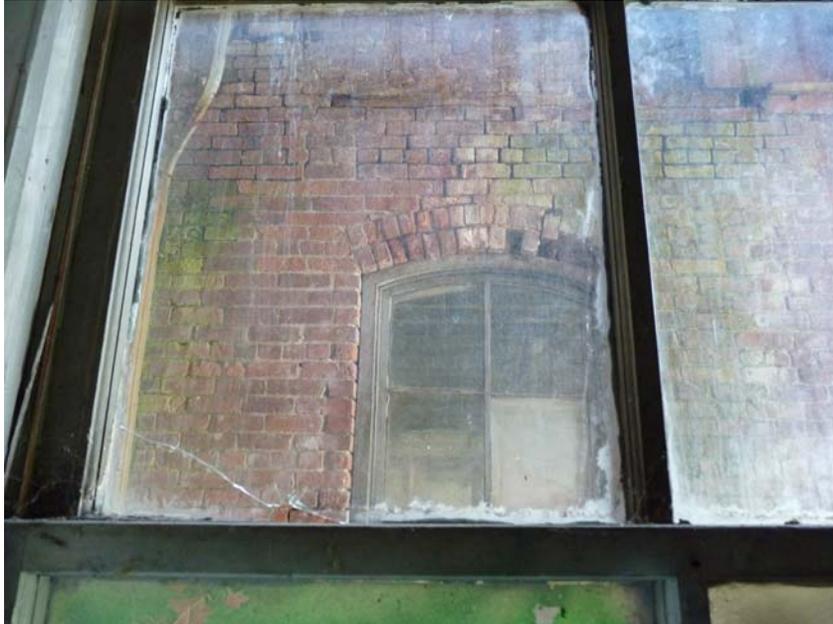
flooring felt soft and weakened, but the supporting joists and beams felt solid. There is some water staining on the walls, but not nearly the degree of distress visible in the remainder of the building. From the second floor window of the east wing it is possible to view the east exterior wall of the main building. The masonry is very damaged, with evident cracking, decayed brick and mortar, and missing bricks, some of which are absent from the arch over the window (see Image 8).

Image 8 Typical Exterior Masonry Damage
(East Elevation of Main Building from East Wing)

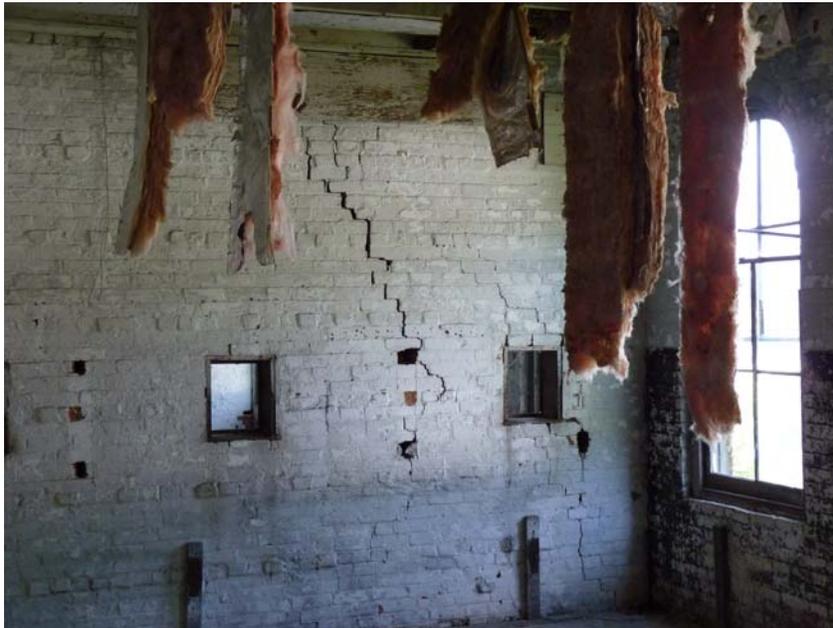
Image 9 Masonry Damage
(Main Building – Second Floor)

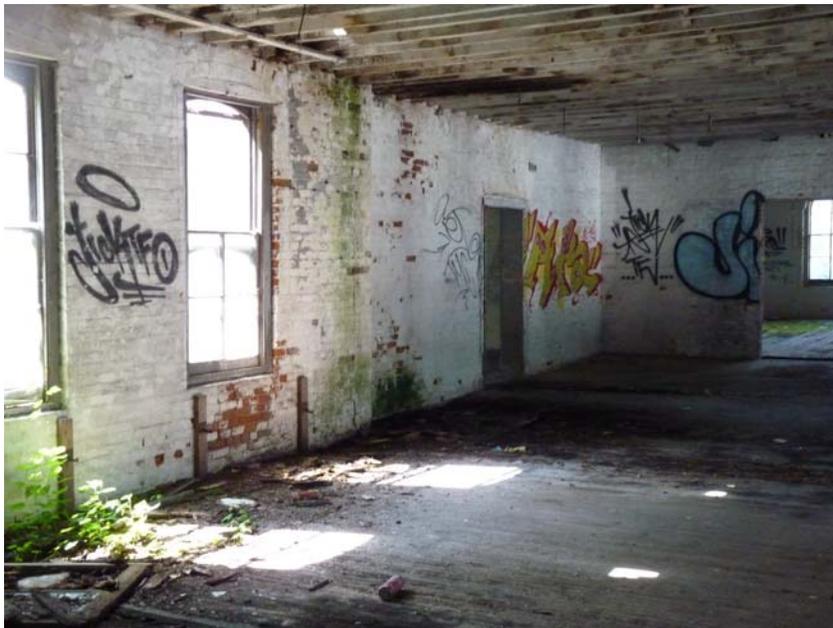
The second floor of the main building is generally not in good shape (Image 10). Sections of steel check plate have been installed as a wearing surface for heavy traffic areas. The round wood posts seemed to be undamaged. While the top of the second floor confirms the observations of damage noted from below, the underside of the third floor is worse. Water damage is much more extensive, though focused at specific areas, the effected areas are larger than noted below. Damage to joists is also more apparent, with more rot and cracking. Cracks in the masonry are generally larger and more numerous (Image 9). Bearing ends of joists in damaged areas look less intact and more cracking and decay of the masonry is also apparent (Image 11). Timber beams seem to be in generally acceptable condition. Lichen is visible growing in patches on the floor. Holes had rotted through portions of the third floor decking. The west side of the building is in particularly bad shape. This area is where the exterior soffit is missing below the dormers. The floor is damaged with extensive amounts of flora growing on it (Image 12). A large width of the third floor framing shows water damage and rot adjacent to the exterior wall. The masonry is heavily cracked and decayed.

Image 10 Typical Water Damage
(Main Building - Second Floor)

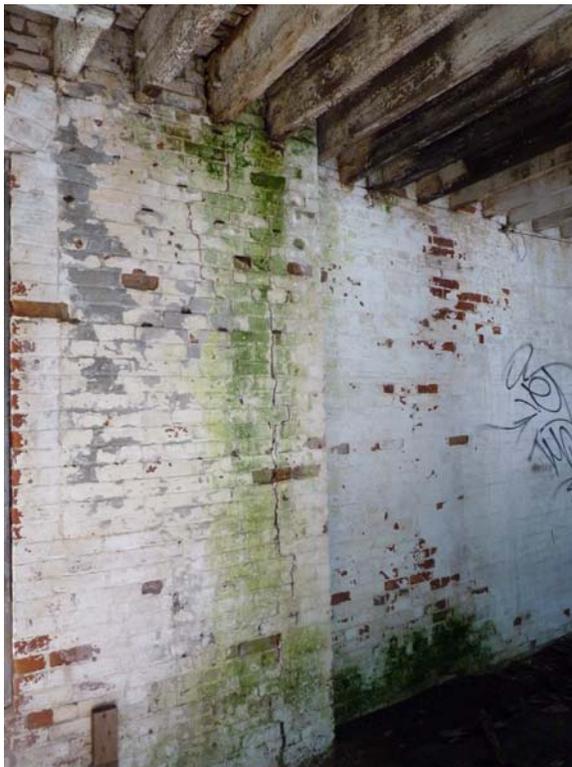
Image 11 Water Damage at Joist Bearing (Main Building - Second Floor)

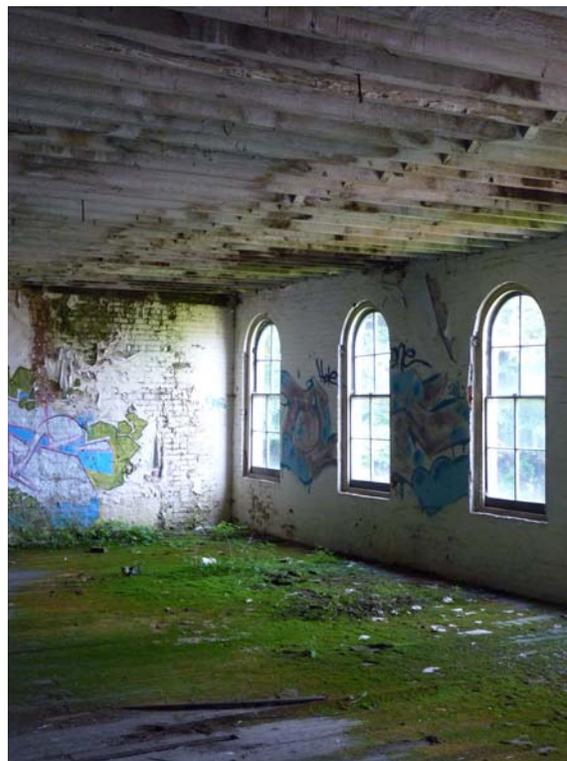
Image 12 Water Damage and Flora (Main Building - Second Floor, West)

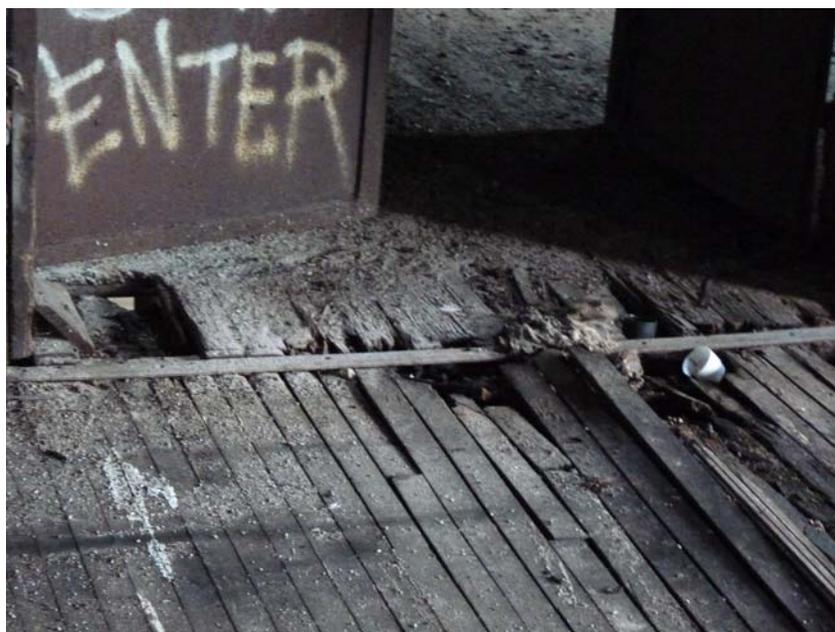
Image 13 Floor Damage (Third Floor transition to South Wing)

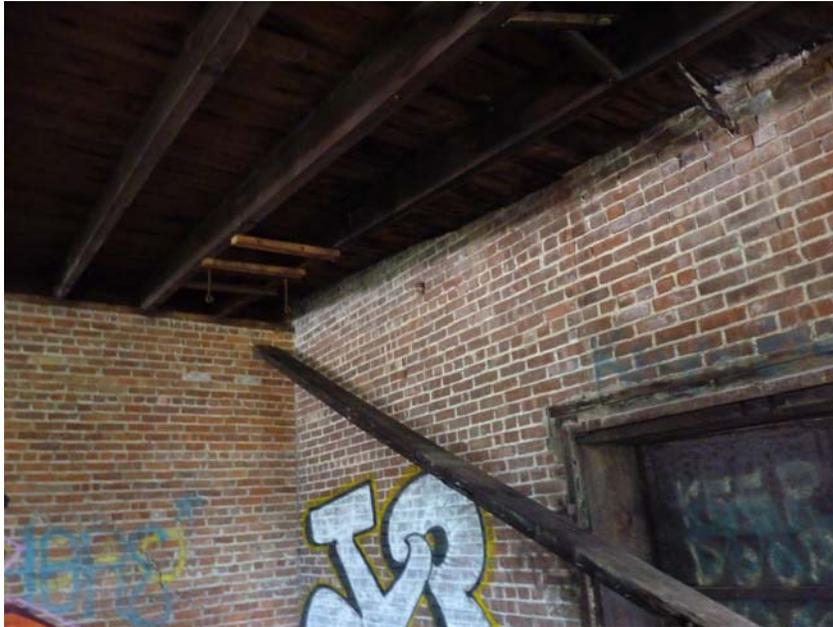
The third floor is severely damaged (Image 17). The wood flooring of the west room has expanded so much from moisture that it has bulged the planks in the center of the room (Image 18). Many areas of the floor have rotted through. A joist at the transition into the south wing had fallen recently (Image 14) and the floor is decayed around the door (Image 13). Sections of the floor in the south wing had also decayed. At the re-entrant corner of the courtyard, the roof framing had rotted through at a connection. The framing members were supported by temporary shores bearing on the third floor deck (Image

Image 14 Recently Fallen Roof Joist
(Third Floor at Transition to South Wing)

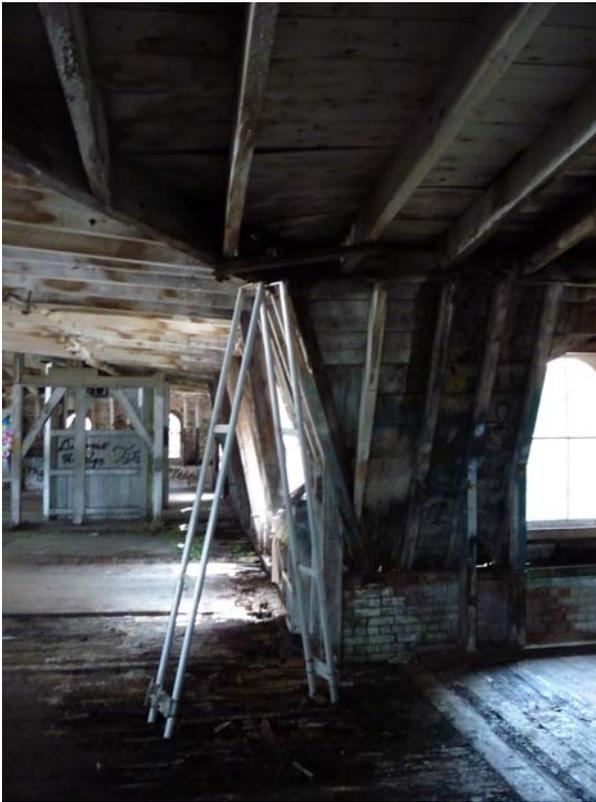
15). While the joists of the attic were decked over, enough sections had rotted out that the roof framing was visible and the large sections of roof that had also decayed (Image 16). The connections for the center roof truss did not appear to be structurally sound. It appears that the roof is close to collapse, which will lead to a progressive collapse of the main building. The roof of the east wing, however, appeared to be intact (see Image 19).

Image 15 Partially Collapsed Roof Framing
(Main Building – Third Floor)

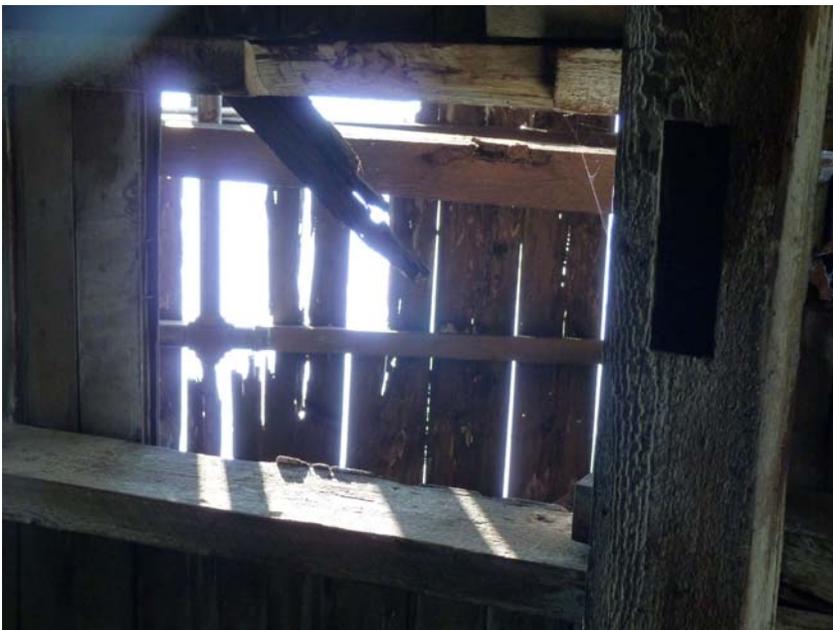
Image 16 Typical Roof Damage
(Main Building – Underside of Roof Framing)

In order to rehabilitate the existing structures, such that they could be structurally viable for residential habitation, all of the wood construction for the main and south wing of the building should be replaced and much of the masonry. The roof of the main building is no longer intact. What remains of the roof and roof framing should be removed and replaced, including the mansard framing and the removal of the existing cornice. The metal roof trusses of the east wing may be salvageable, but the metal roof deck should be replaced. All of the floor deck throughout the building for the second and third floors is either rotten or has sustained water damage and should be replaced. While very few of the floor joists appear to be structurally sound, most of which frame the second floor, a significant percentage show signs of decay, and almost all are likely to grow mold due to the moisture exposure. It is recommended, therefore, to replace 100% of the floor joists instead of trying to pick out the few that could remain yet still have the potential for future mold issues. The fitch beams framing the floors of the east wing appear to be in fair condition and may be salvaged. However, their structural capacity may be inadequate for re-use without further reinforcing.

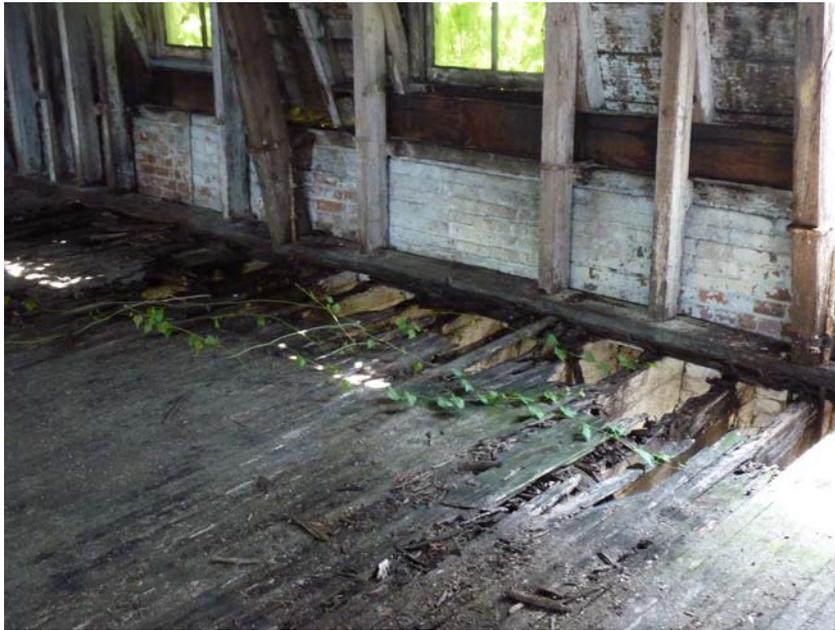
Image 17 Typical Water Damage Below Mansard Framing
(Main Building – Third Floor)

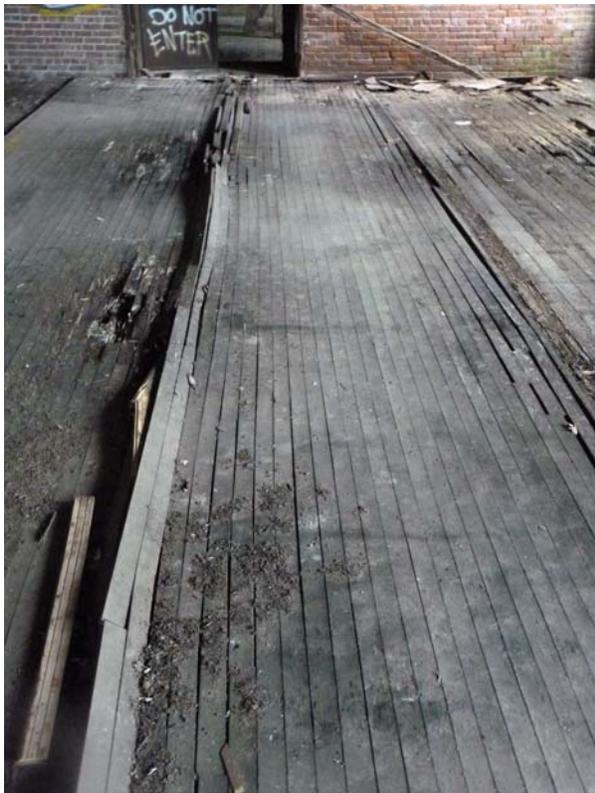
Image 18 Flooring Expansion Damage
(Main Building – Third Floor)

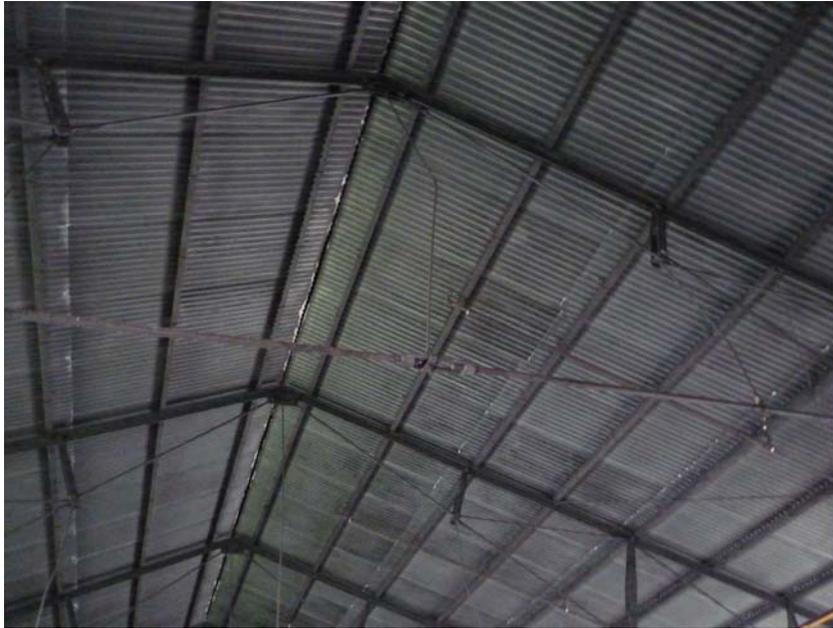
Image 19 Metal Roof Trusses and Decking
(East Wing – Underside of Roof)

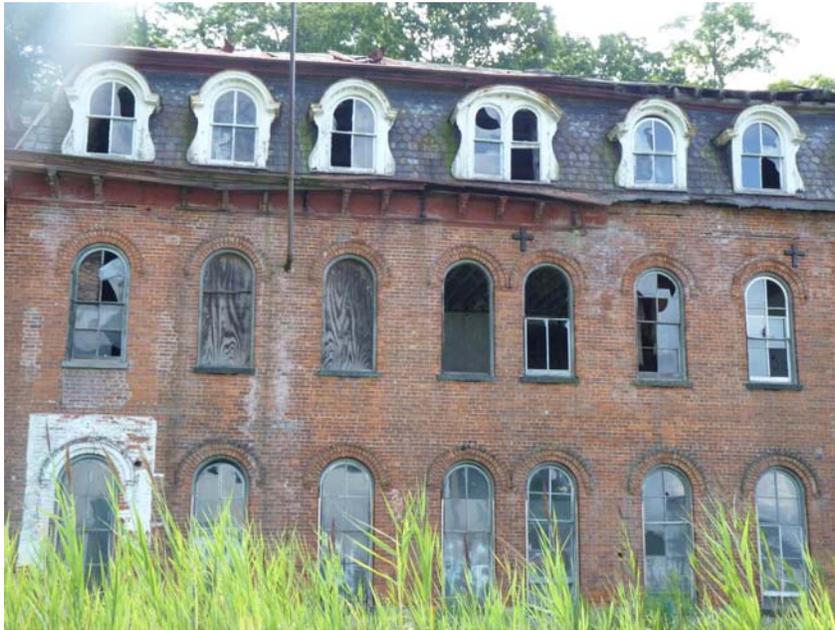
The building has been open to the elements for some time (Image 20). Rain and snow have had free access to the interior of the building and have slowly been rotting and eroding the structure. Moisture trapped in the masonry walls during the winter freezes and expands damaging the masonry and causing it to decay. Apparently, a lot of decay has happened in the last ten years, and the rate of decay can be expected to continue to increase. Several single-story out-buildings that looked intact apparently collapsed when nudged by a backhoe. The Mill Building may be in a similar state of decay.

Image 20 Main Building – North Elevation
