15 June, 2018

Re: Structural Assessment of Existing Building – 2018 Update  
Hidden Cove Development - 36 No. Water Street  
Village of Ossining, NY

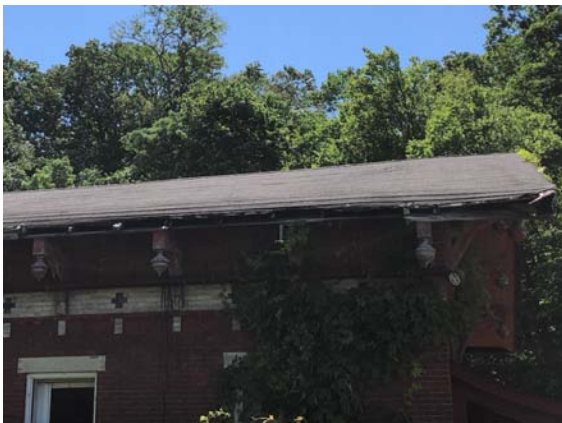
- a. There is clear evidence of proliferated structural deterioration both outside and inside. Images 1 and 2 depict the state of disrepair of the wood framing. The roof framing is unprotected, and has been exposed to 6 more seasons of freeze/thaw cycles since the last assessment.

**Image 1 – Roof Exterior**

Roof sections have failed. Roof rafters and collar ties have further deteriorated, are significantly waterlogged, and structurally deficient.

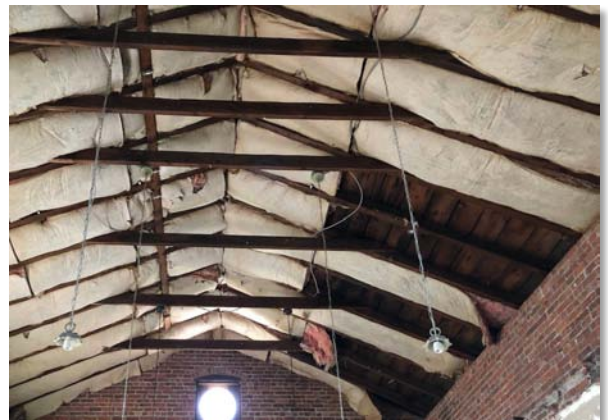
**Image 2 – Roof Interior**

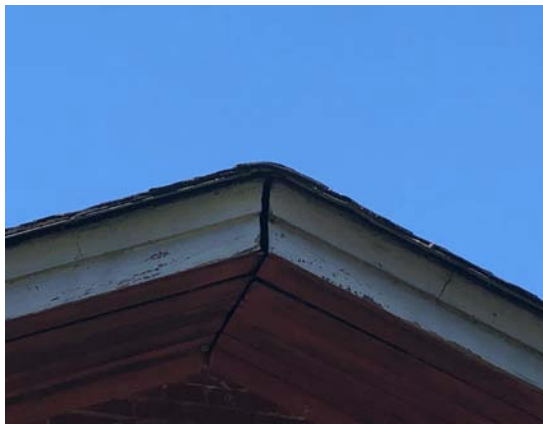
- b. The existing roof framing as constructed would not meet current structural requirements for such a system, and does not meet with NYS Code requirements. The rafters are undersized for the given span, spacing, and loading. The collar ties at alternate rafters are inadequate and too high from the eave, yielding a residual horizontal thrust at the ends which are bearing on the masonry walls, with no capacity in the unreinforced multi-wythe brick walls to resist the lateral forces. This in turn has caused the roof framing to 'spread' outward, evident by the increase spread at the roof ridge line (Image 3), and cracking the brick bearing wall (Image 4)

**Image 3 – Roof Ridge Separation**

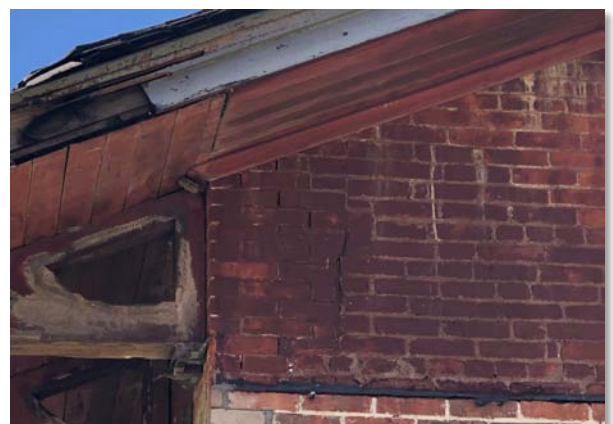
**Image 4 – Wall Stress Cracks At Ends**

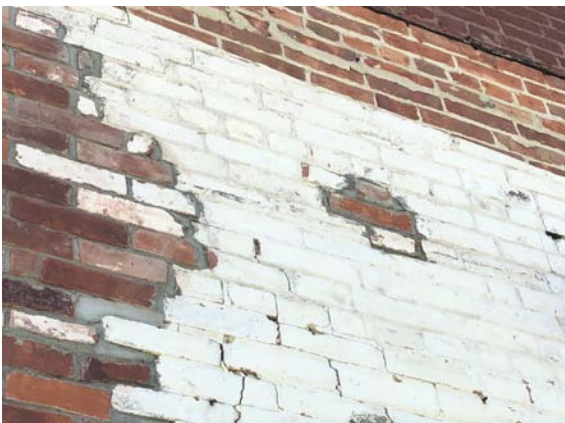
- a. Further deterioration of perimeter brick walls was evident throughout. Newly formed cracks were discovered in the same areas which had been previously patched (Image 5). New cracks throughout are demonstrative of continued structural stability deterioration of the walls. Continued deterioration is directly due to ongoing water infiltration washing out of what remains of the mortar joints, further decaying the brick and mortar remnants of the unreinforced walls (Image 6).

**Image 5 – New wall cracks**

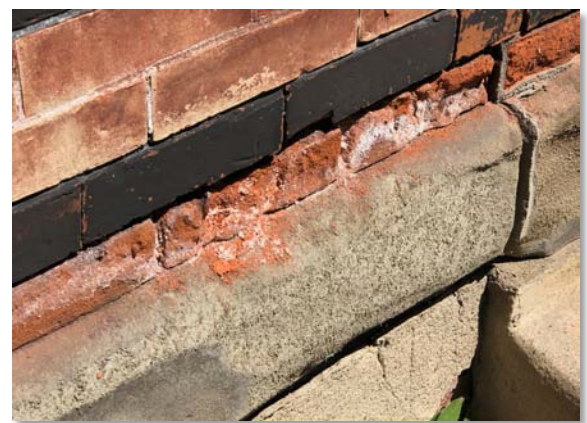
**Image 6 – Deteriorated bricks and mortar**

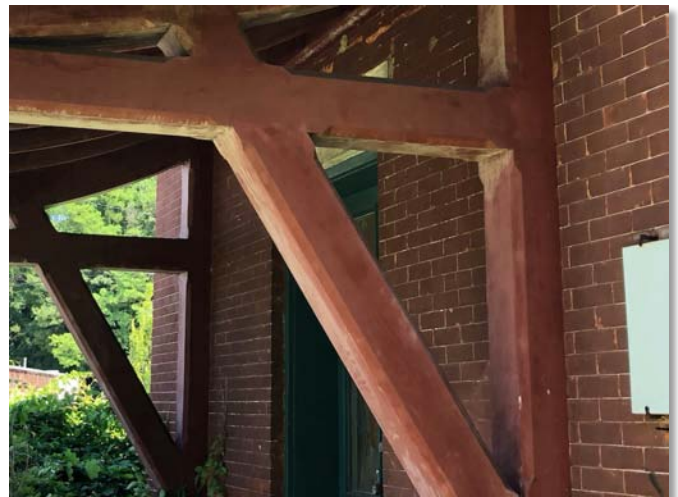
**Image 7 – Front Entrance Facade**

While it will be impossible to use the old brick for structural purposes, some bricks can be salvaged and re-used as veneer for commemorative purposes. However, there may not be a significant number of bricks salvageable to achieve any sizeable commemorative element. The best source for salvage may be at front façade near the entrance of the building. This area is partially covered and has relatively less damage than other areas, and may yield some brick for veneer re-use (see Image 7). The size of any commemorative element will be highly dependent on how much of this brick can be salvaged.
