STRUCTURAL INSPECTION

Hidden Cove Development

June 2, 2015

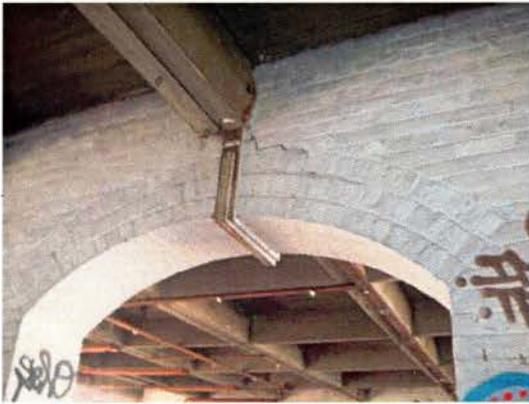
Image #1

The fitch beams are intact and very rust is evident on the edges of the steel plates however due to damaged brick bearing walls below them, some of the beams have twisted and dropped in areas creating an uneven floor surface above.

The flooring on the 2nd and 3rd floors has become extremely soft and unstable due to water damage and each floor is entirely covered with water, feathers and animal feces most likely from geese or other birds who have found refuge through the broken windows. Areas of the floor are open to the floors below and the stairwell is not entirely stable.

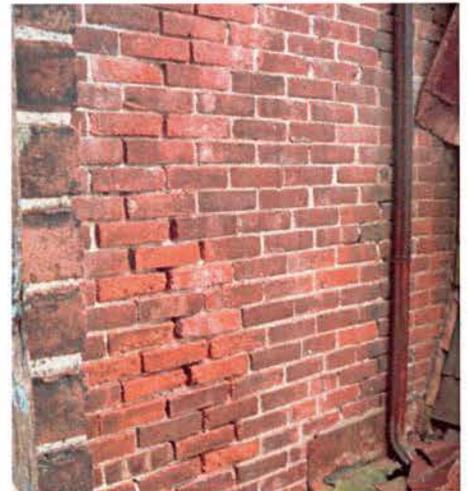
Image #2

The inspectors entered the Mill Building through a pass through that connects the two structures. The flooring and walls in the pass through are in extremely poor condition. The flooring is dangerously soft and unstable and the brick masonry walls have shifted and cracked below the window openings. The exterior of the pass through is visible from the windows in the Mill Building and the inspection revealed that the bricks were extremely eroded and a good portion of the brick joints had no mortar in them at all. (see image #2)

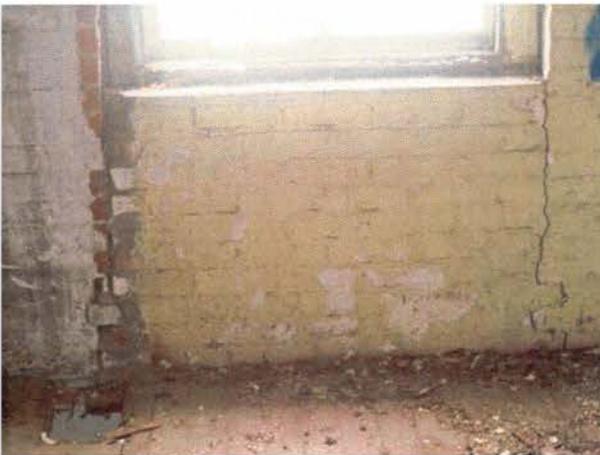
Image #3

The Mill Building is constructed similarly however the floors are framed with wood joists, not fitch beams, and the structure is much older than the East Wing. The brick masonry walls have been exposed to the same flood waters as the East Wing and damage is evident throughout the structure. Much of the mortar between the bricks on the lower 2 feet of the building has been washed away and severe cracking is visible at bearing walls and window/door openings. (see images # 3 & 4)

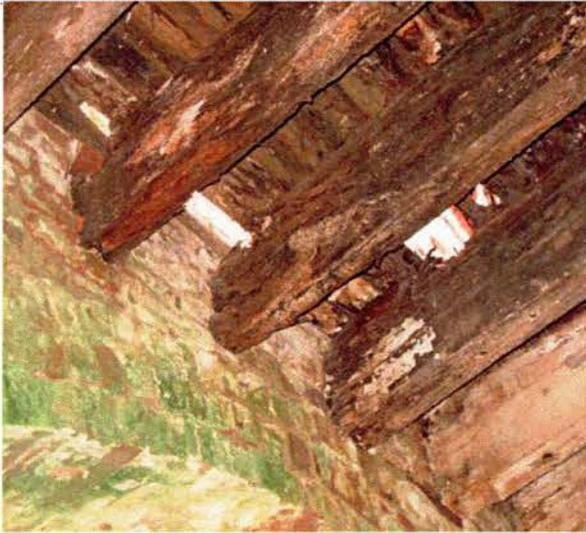
Image #5

There are multiple locations where holes in the roof and exterior structure have allowed rain water to infiltrate the structure and caused severe water damage to the wood joists and subfloor. In particular is the interior corner of the Mill Building adjacent to the previous "Muslin Room" as shown on the site plan.

There is a pool of water on the lower level in this area, the joists in the first floor ceiling have organic matter growing on them and they are black due to water damage. The bearing ends of the joists are soft and the tops of these joists have rotted away. The 2nd floor ceiling framing in the same area is similarly damaged. (see image # 5)
